# Four Beef-cattle Barn Flooring Options: A Case Study

Steve Higgins, *Biosystems and Agricultural Engineering*

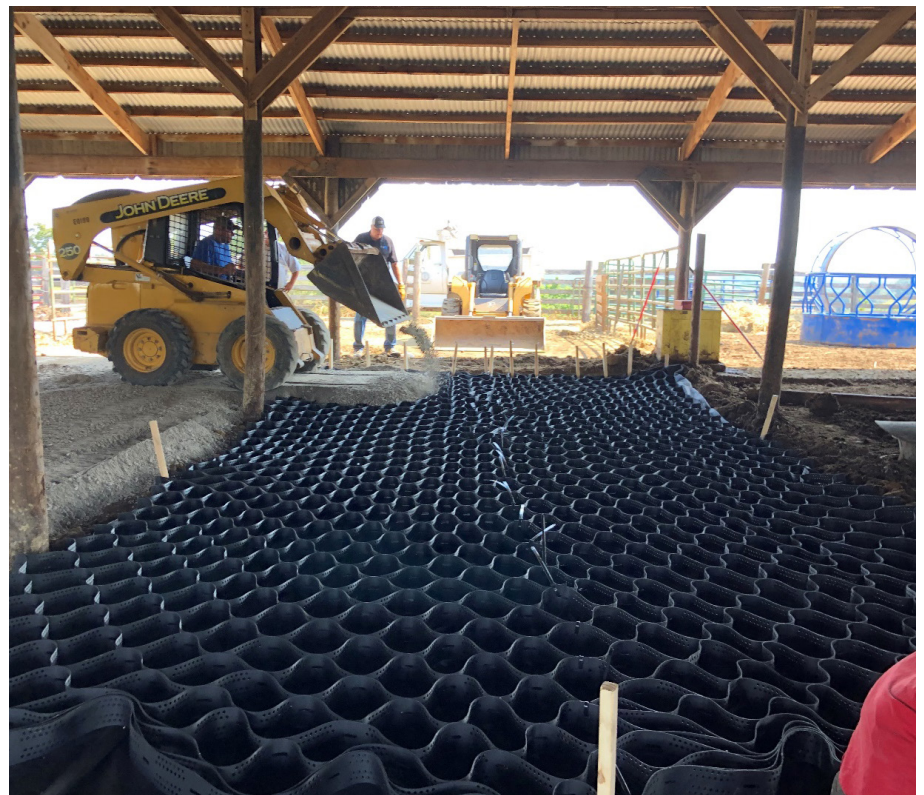
**Figure 1.** A four-inch geocell product was installed to create pervious flooring.

A geocell product was available in four-inch and six-inch depths. The four-inch geocell material was used by laying down geotextile fabric. The geocell was

stretched out and staked, using two-foot stakes. Adjacent geocell sections were tied together using zip ties. Dense grade aggregate (DGA) was backfilled into the voids (Figure 1).

The geocell product walls seemed to be too flimsy for placing the rock. However, observations of the rock being placed showed that the geocell did hold up. How well it lasts will be determined later.

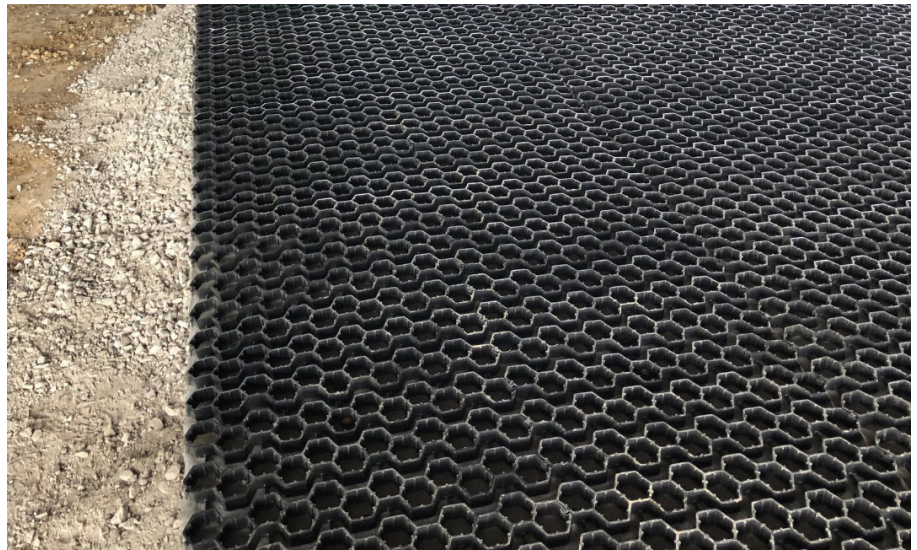
**Figure 2.** A plastic grid material backed with a geo-fabric material, which came in a roll 4 feet wide by 150 feet long, was used to create a pen treatment.

A 4 ft by 150 ft roll of plastic grid with a geotextile backing was used to create this treatment. A base layer of filter fabric, topped with six inches of DGA was placed and leveled within two inches of the final grade. Four strips of a two-inch layer of interlocking plastic grid, with a filter fabric backing, was placed on the rock, connected, and then backfilled with

DGA (Figure 2).

The ease of installing the plastic roll made it a nice choice. However, the gravel had to be completely level before adding the plastic grid with the geofabric backing. Otherwise, voids could produce deflection or an unwanted hollow feel when walking on it. Experience with other plastic grid materials indicate that, for this application, it would be easier and possibly better if we had used the roll without the fabric backing. This would allow the installer to lift the grid where needed, with the rock installed, which allows the rock to fall out, and create a level surface.

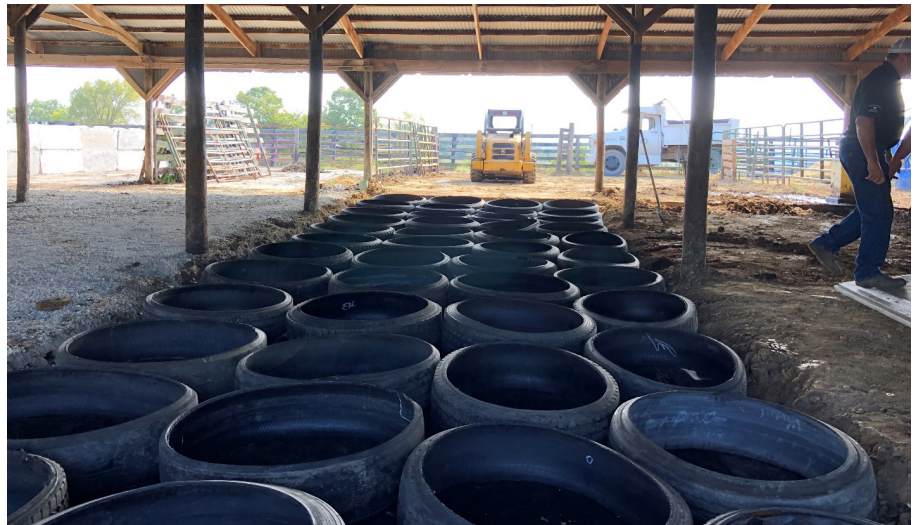
**Figure 3.** Mechanical Concrete® is a process by which tread cylinders are used to contain the rock and control lateral stress. Photo by Brett Childers

Mechanical Concrete® is a process in which the sidewalls of used truck tires are removed, leaving a tread cylinder. The tread cylinder was placed on top of a layer of geotextile fabric (Figure 3). DGA was then placed inside and around the tire voids. The goal was to have the top edge of the tire cylinder be at grade level.

The tires were arranged using a straight row pattern as opposed to an offset pattern. This layout resulted in a larger void between the tires compared to the offset pattern. It also required fewer tires. With this option, it appears that it would take a long time before a loader bucket could penetrate the thick edge pattern created by the tread cylinders. The cost difference between a traditional DGA and fabric application versus the Mechanical Concrete® was \$772 compared to a traditional filter fabric and rock pad, which would have cost \$716. The contribution that the tires provided to the treatment gives the impression that the lifespan of the floor was increased significantly compared to a traditional filter fabric and rock implementation, which is expected to last 10 years with proper maintenance. The addition of the tires cost \$56 which seems like a small price to pay for extending the life of the floor by several fold.

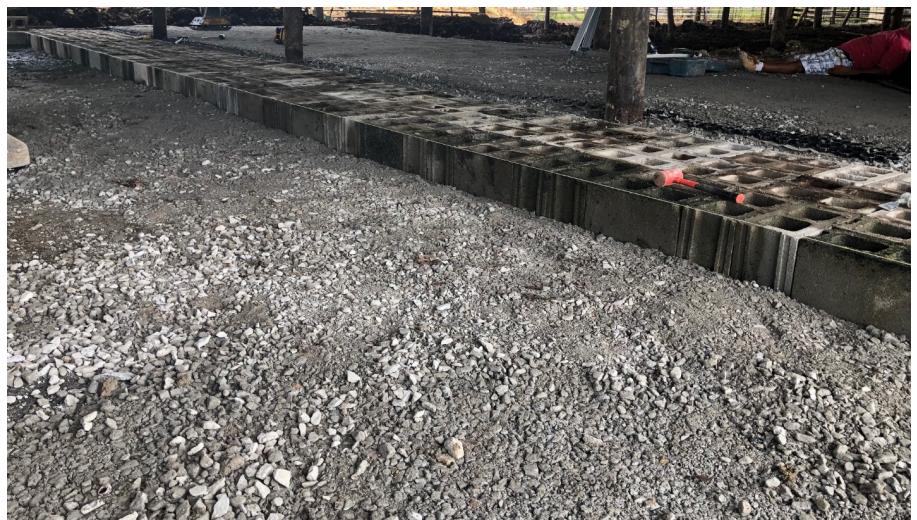
**Figure 4.** Cinder-block flooring treatment being placed.

The cinder-block treatment was created by laying down filter fabric, placing the blocks (open end up), and then backfilling with DGA (figures 4 and 5). This treatment should provide a 49 per-

cent pervious surface. The surface of the blocks acts as the final edge or surface to facilitate manure removal with a bucket loader but without removing rock.

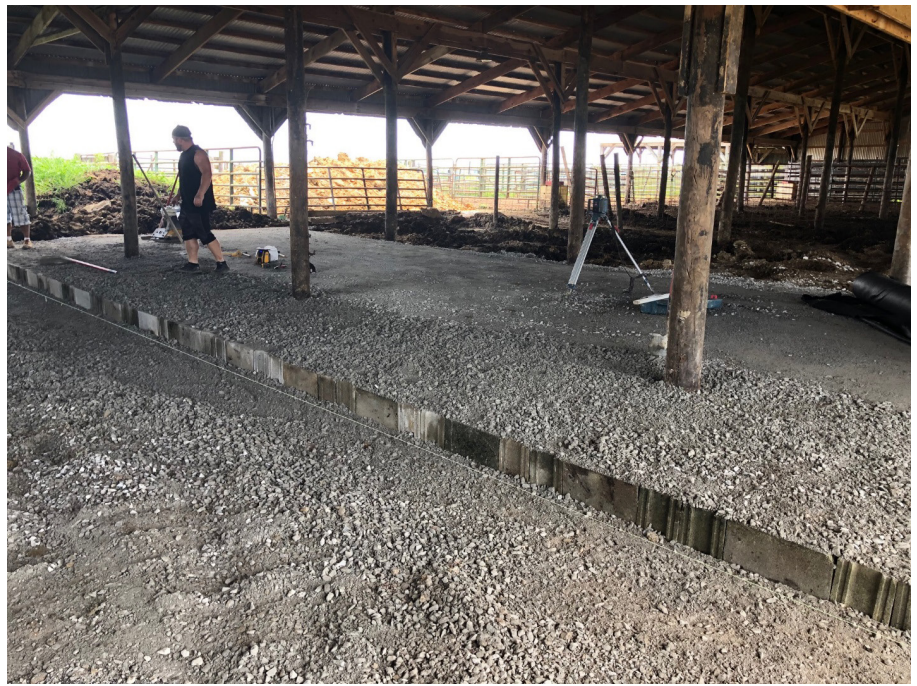
Figure 5. Backfilling and plate compacting DGA into cinder block voids.

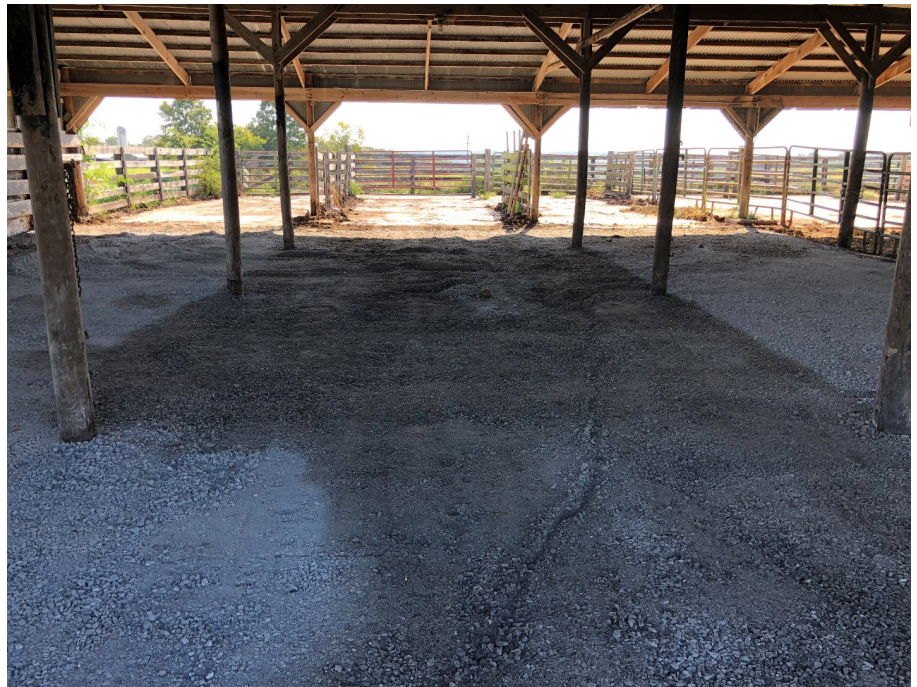
Figure 6. Moisture present in the cinder-block flooring treatment.

The cinder-block flooring treatment was the most labor intensive treatment with each block weighing approximately 30 lbs. After a few days, the surface of the DGA showed a noticeable amount of dampness (Figure 6). In addition to providing infiltration, cinder blocks absorb moisture from the environment. The blocks are analogous to a sponge as they wick moisture from the atmosphere or environment. A bench top lab study suggested that each block could store one-gallon of liquid. The observation of moisture does suggest that a disadvantage of this flooring might be that it draws moisture to the surface, near a lying animal and bedding. Additional observations and measurements would need to be collected to determine the outcome of this effect.
